Major Accident Case Studies

Buncefield explosion and fire

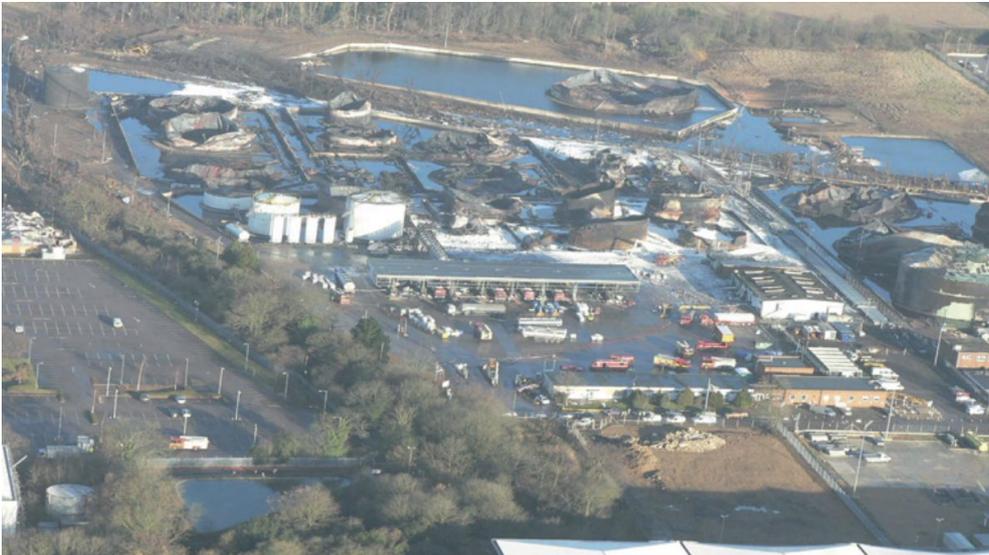
After the incident

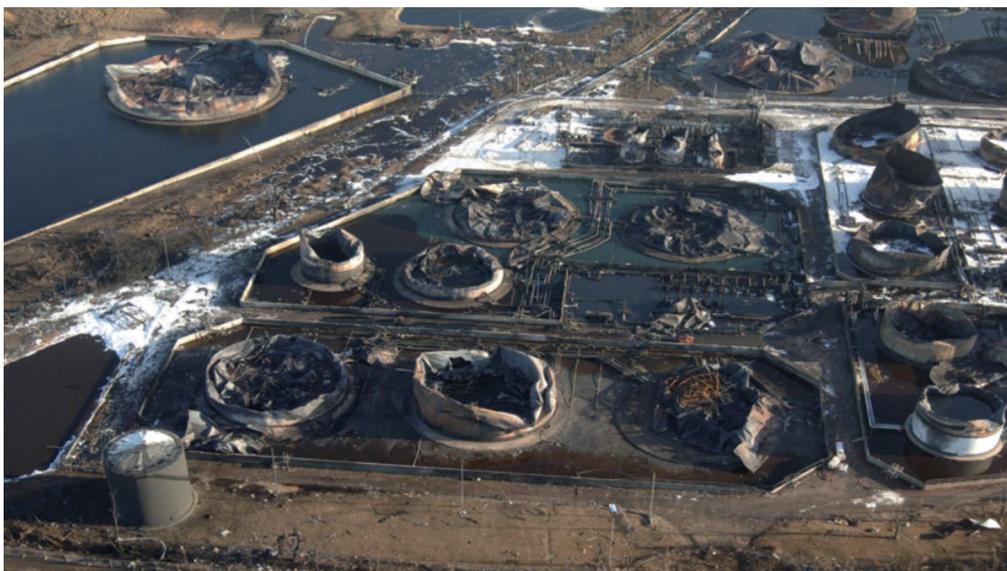
After the incident
